METHODOLOGY FOR THE CONTROL OF BEACH NOURISHMENT IN THE GULF OF CADIZ (SW SPAIN)

INTRODUCTION

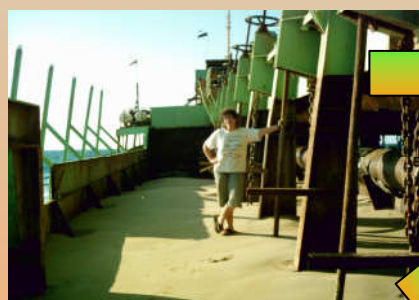
figure 1: technician over the sand accumulated in the hopper.

So, distance between deck and sand surface are measured at the end of each loading phase by the representatives of contractor and government respectively in order to calculate the sand volume by using vessel ullage chart.

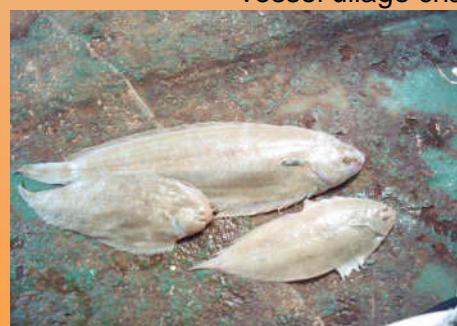
As the controlling technician was a sea science bachelor, she was charged as well with the environmental tasks, e.g. to identify, weigh and number the fishes trapped into the hopper.
